Wilmette Public Library

Capital Reserves Study

WORKING DOCUMENT - AUGUST 5, 2020

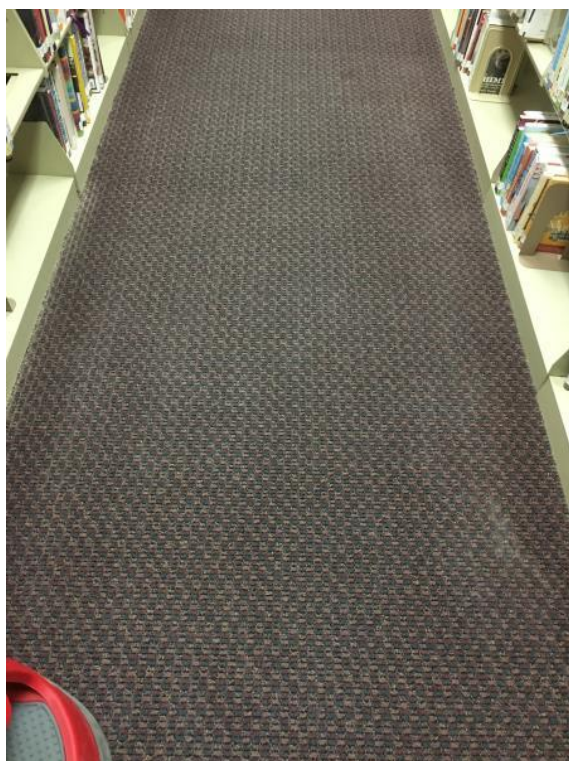
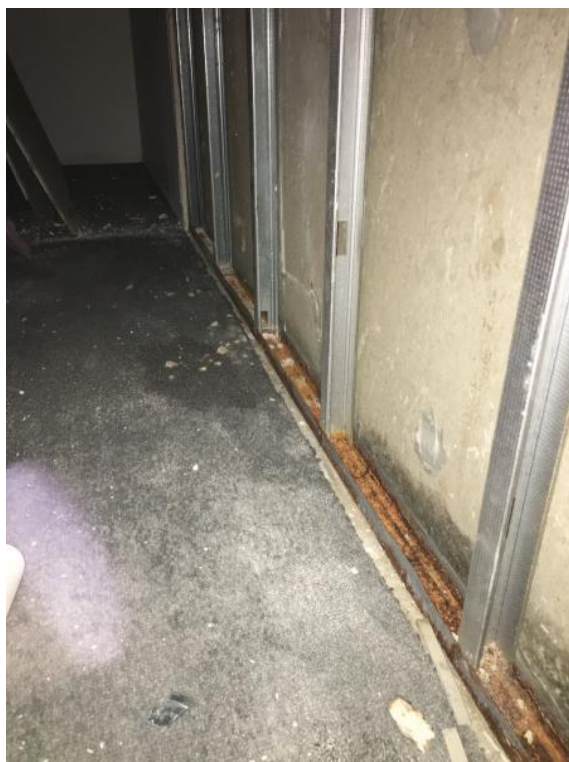
*Top: Stained carpet in basement
Bottom: Water damage along south foundation wall*

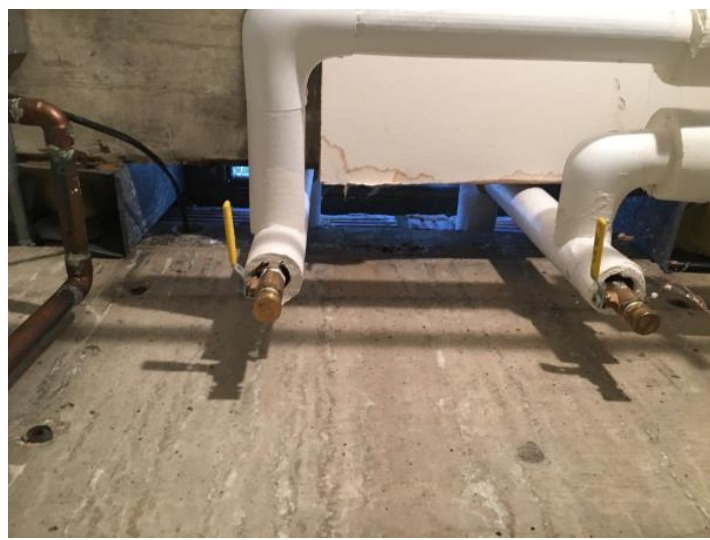
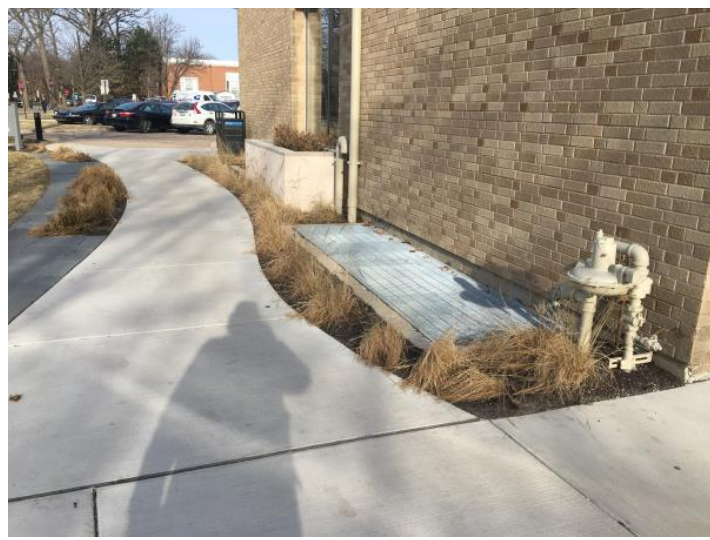
*Top: Water staining at location of area well
Bottom: Top of area wells below sidewalk*

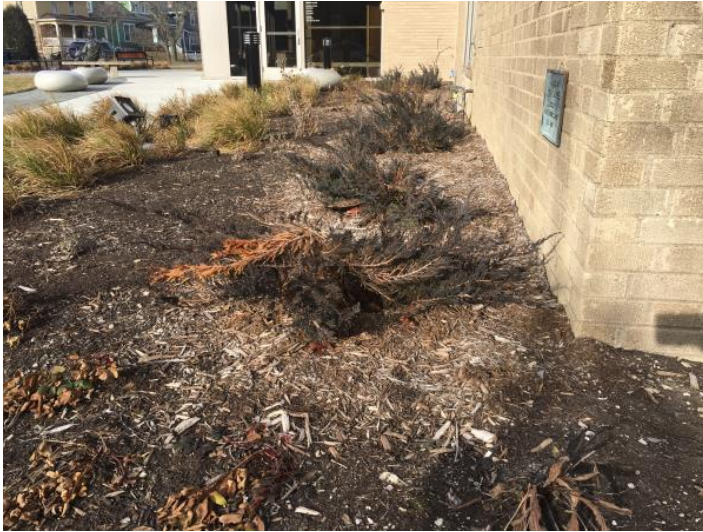
Top: Landscaping along west wall above brick ledge and area well
Bottom: Landscaping above brick ledge south side of building

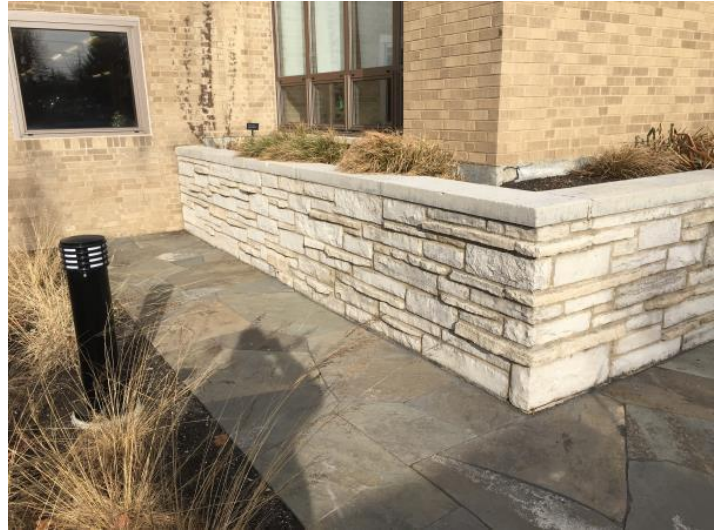
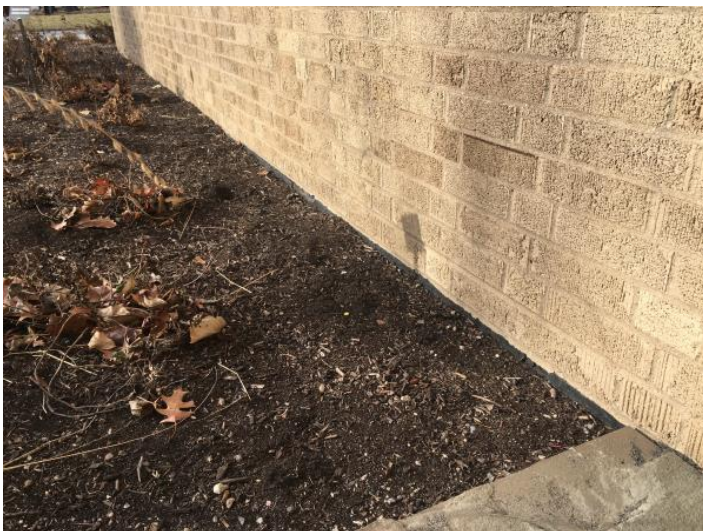
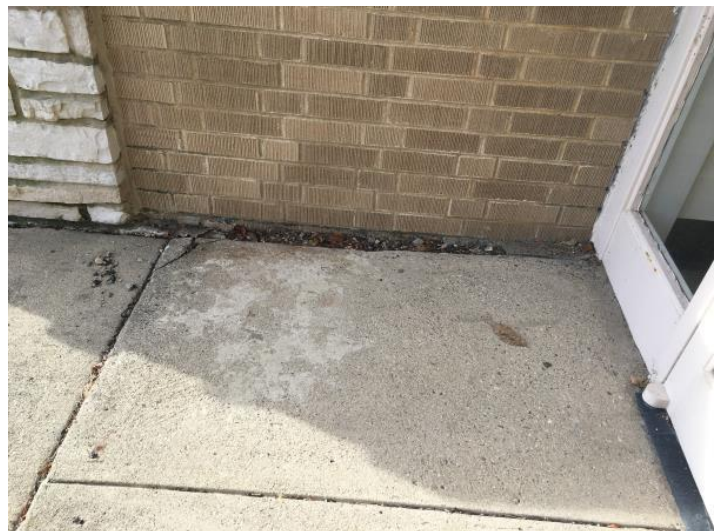
Top: Elevated planter wall extending past raised foundation wall and flashing in disrepair
Bottom: Sidewalk at door east of elevated planter above brick ledge

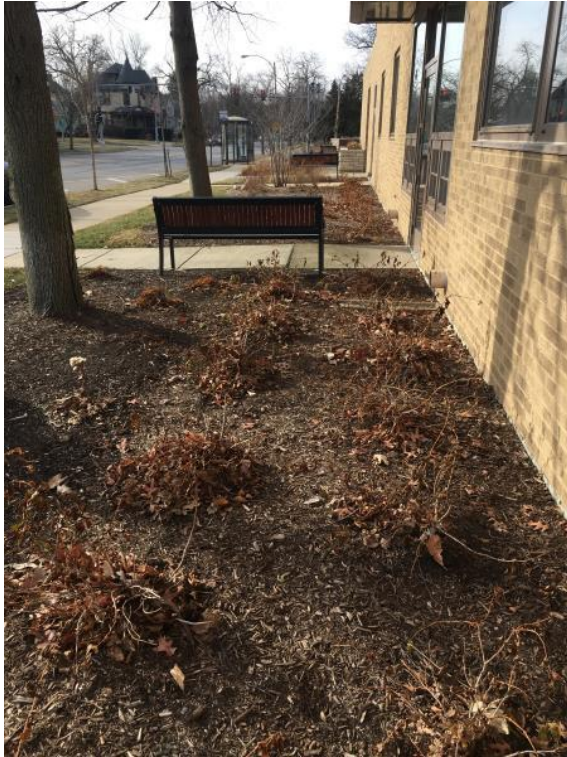
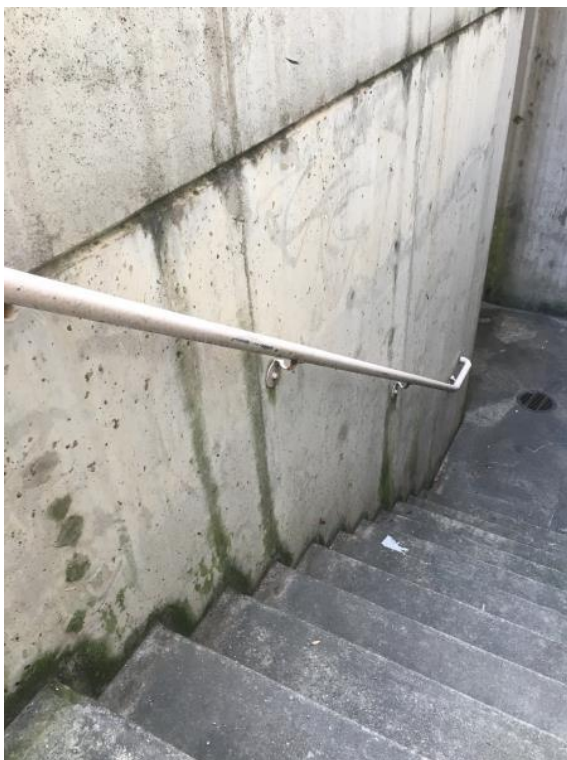
Top: Splash blocks and landscaping pitched toward south side of building (section of sidewalk at door potentially pitched to door)

Bottom: Water infiltration (east exterior stairway)

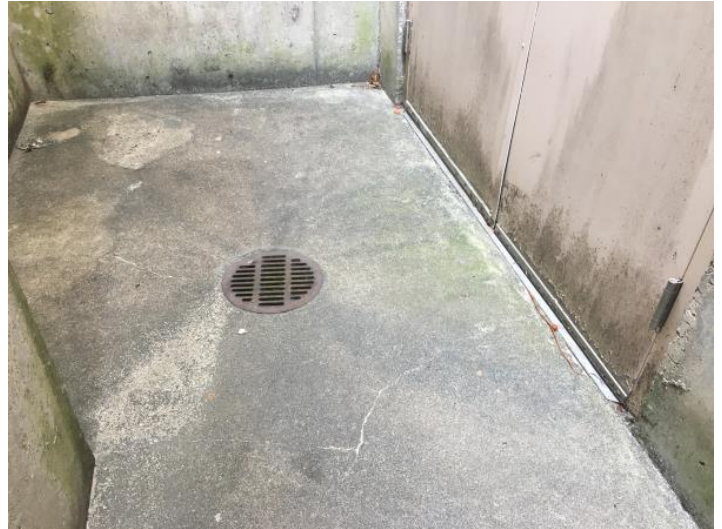
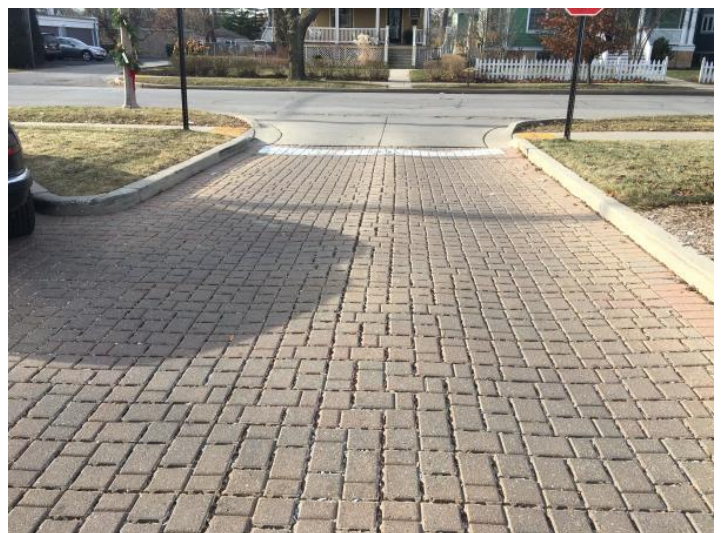
Top: Water damage at bottom of door (east exterior stairway)

Bottom: Rutting of pavers at Exit to Park Avenue

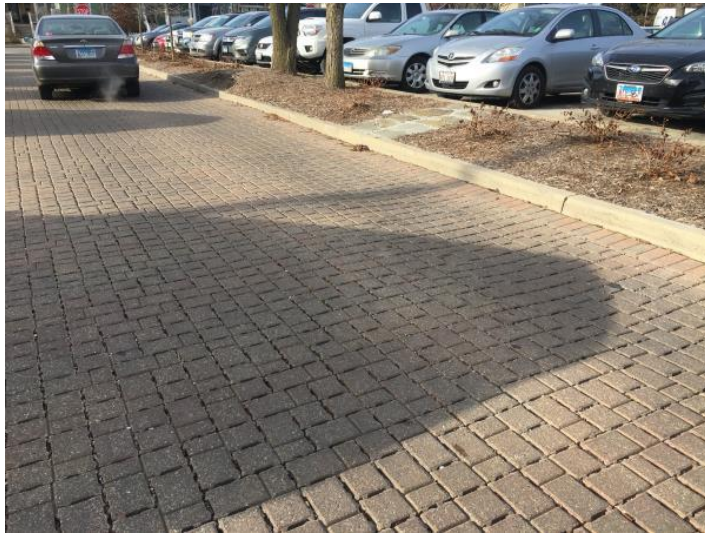
*Top: Rutting of pavers along west drive lane
Bottom: Rutting and separation of pavers at Book Drop*

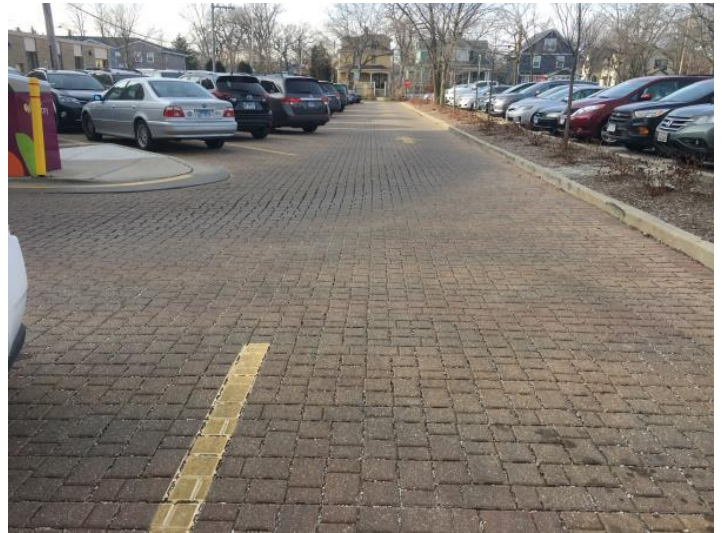
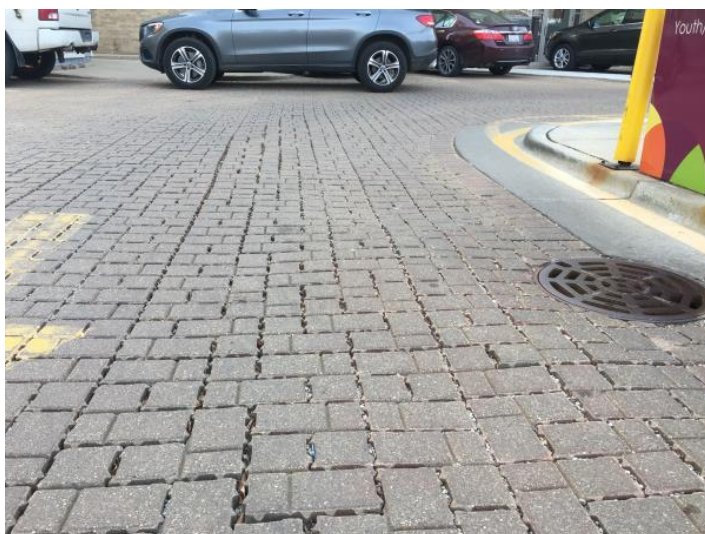
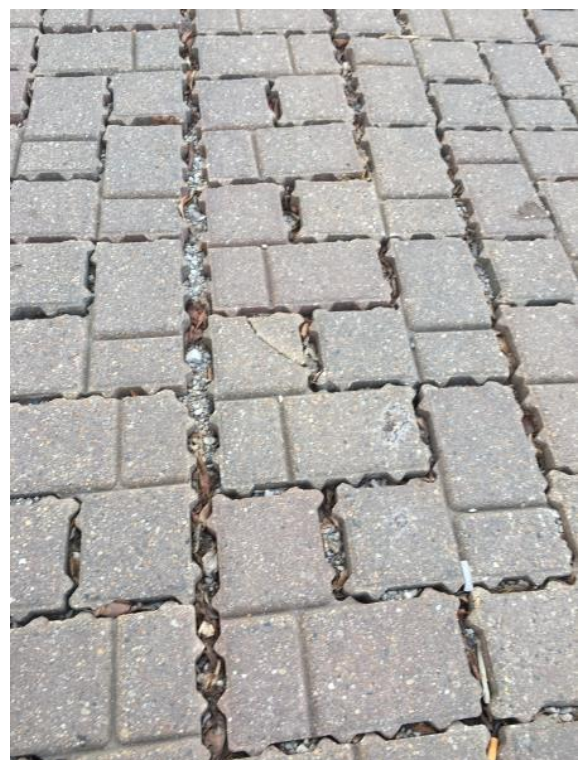
*Top: Rutting of pavers at turn adjacent to Book Drop
Bottom: Typical separation of pavers at rutting locations*

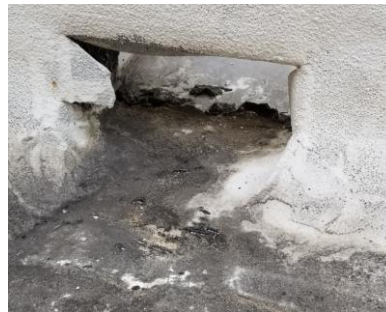
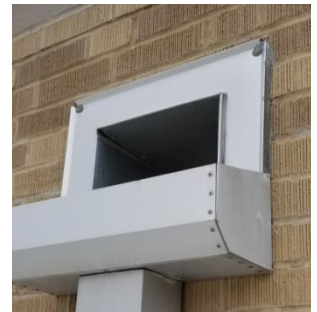
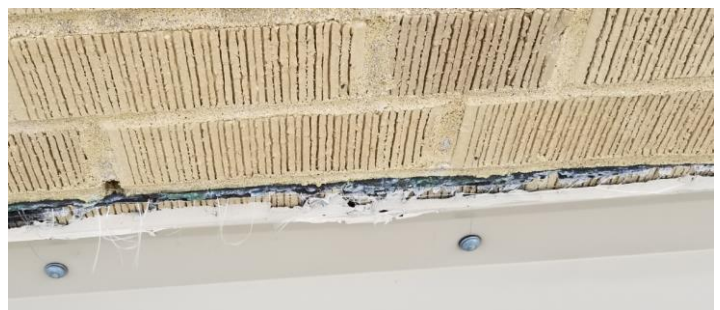
- Roof 06a is drained to Roof 04 through a scupper. The membrane flashing around the scupper is failing. This should be repaired immediately. Scupper was clear of debris.

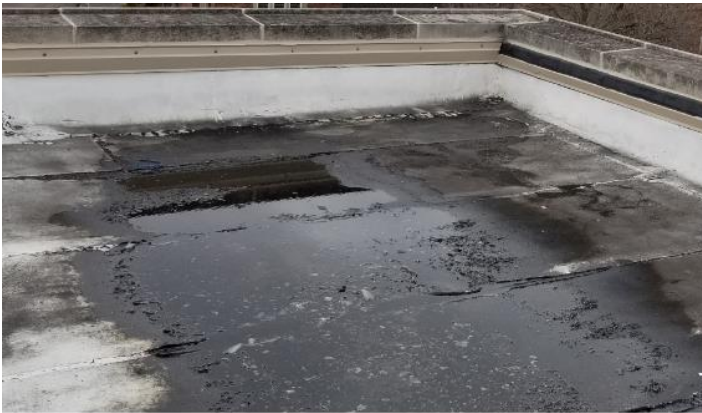
- Roof 07 appears to be a multi-layer modified bitumen roof membrane material manufactured by Siplast. This roof appears to be in fair/poor condition. Some cracking and wear was observed. The perimeter is stone coping. Roof drains were clear of debris. This roof has (2) mechanical units, a railing, a skylight and a chimney.
- See South Skylight. See Upper Chimney.
- It is recommended that a roof walkway pad be added between the access door, mechanical units, and roof ladders.
- Several locations were noted with standing water.

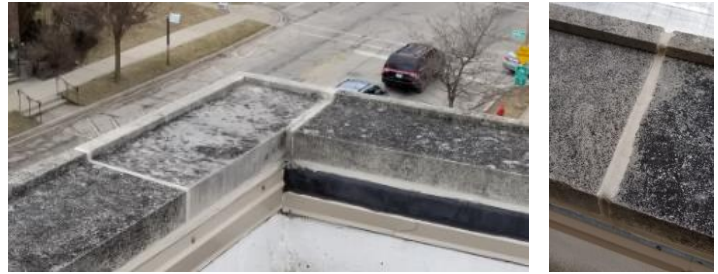
Stone Coping

- All stone coping locations need to be cleaned.
- All vertical and horizontal joints are sealant. Sealant needs to be replaced.

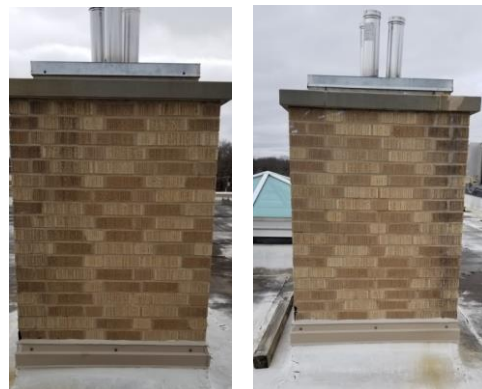
Upper Roof Chimney

- The metal flashing at the North Chimney requires the sealant to be replaced. The sealant is either failing or is cupping allowing water to pool.
- The brick should be tuck pointed. (20%)

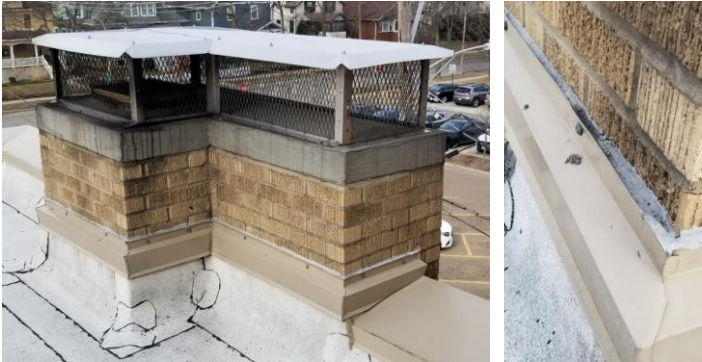
Lower Roof North Chimney

- The metal flashing at the North Chimney requires the sealant to be replaced. The sealant is either failing or is cupping allowing water to pool.
- The brick should be tuck pointed. (75%-80%)

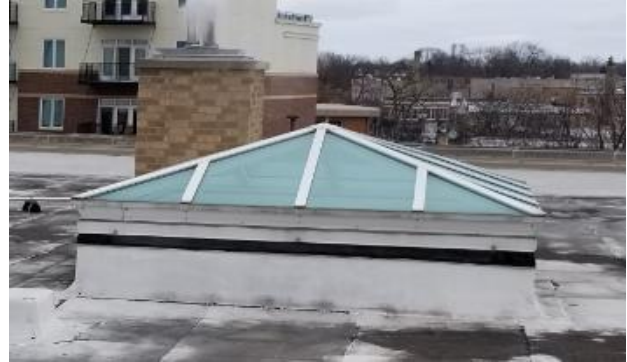
South Skylight

- The south skylight is square and is in good condition. The skylight should be reviewed annually for sealant integrity and signs of wear.

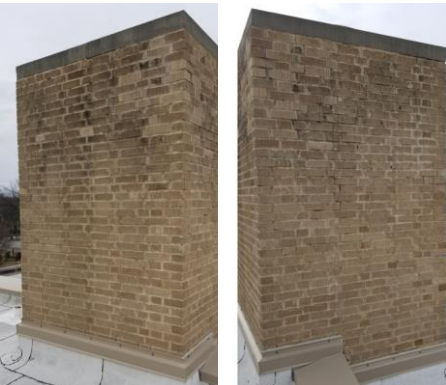
Lower Roof South Chimney and/or Elevator Overrun:

- The metal flashing at the North Chimney requires the sealant to be replaced. The sealant is either failing or is cupping allowing water to pool.
- The brick should be tuck pointed. (50%)

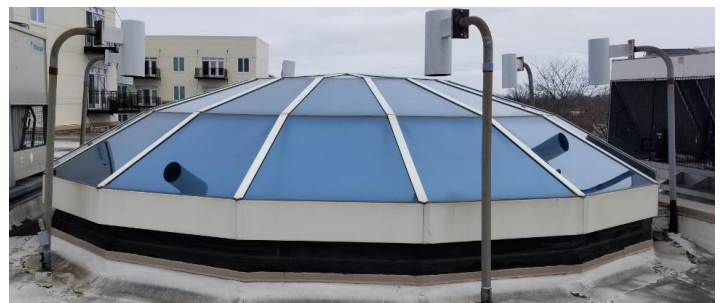
North Skylight:

- The south skylight is a segmented circle and is in good condition. The skylight should be reviewed annually for sealant integrity and signs of wear.
